Manhole Inspection Summary

Manhole # S41CC_033MH

Insp Date: **12/12/07 10:46 AM**

Location Address: **eden and eager park**

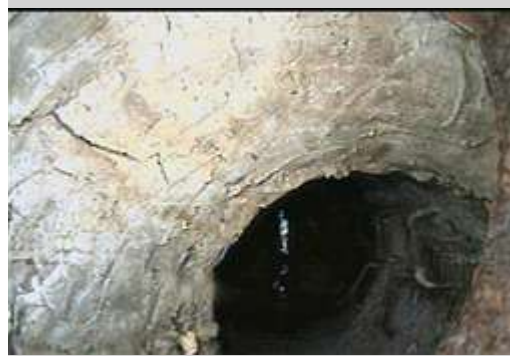
Top View

best view considering offset

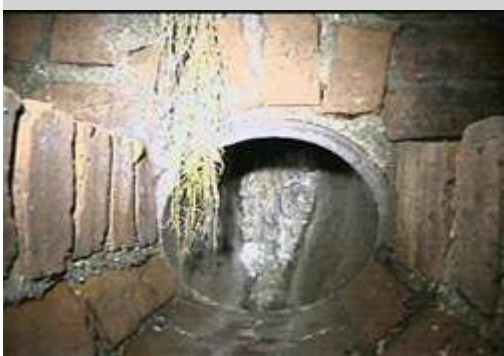
Defect 2

Condition: ☐ Sound ☐ Cracked ☒ **Root Intrusion** ☐ Loose Brick ☐ Deteriorated

Roots in barrel near 6 O'clock connection

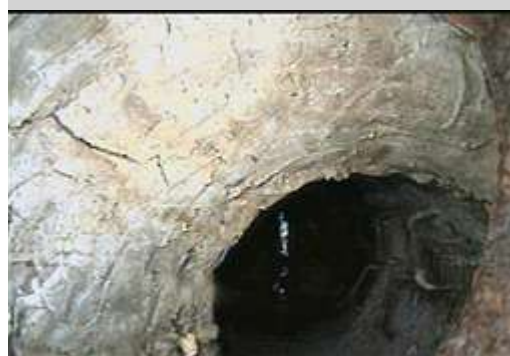
Defect1

Frame Offset: **8** (in.) Condition: ☒ Sound ☐ Cracked ☐ Leaks

Steps Count: **5** Missing: **0** ☒ **Corroded**

Frame offset & Corroded Steps

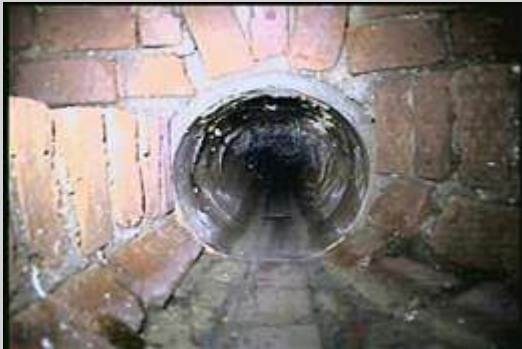
12 O'Clock Outflow

8 in. Circular Gravity Sewer
Pipe Out @ 12 O'Clock

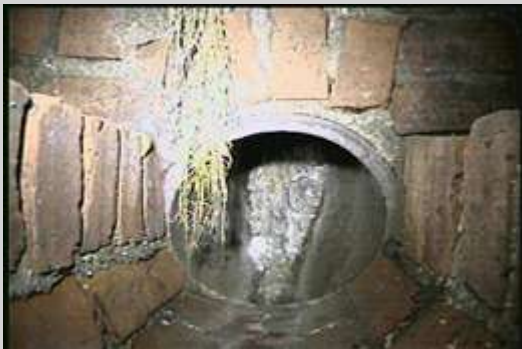
6 O'Clock Inflow

8 in. Circular Gravity Sewer
Pipe In @ 6 O'Clock
